Manhole Inspection Summary

Manhole # S13QQ1016MH

Insp Date: 11/1/06 9:18 AM

Location Address: **4901 POE AVE**

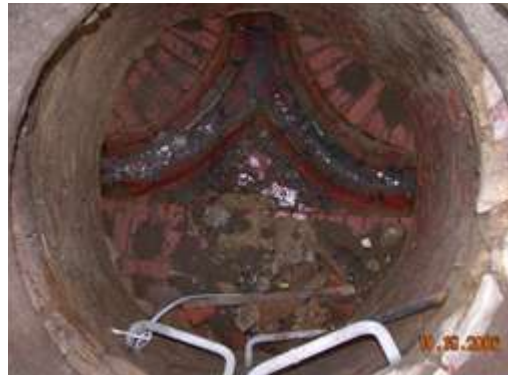
Top View

Evidence of surcharge - Bench debris.

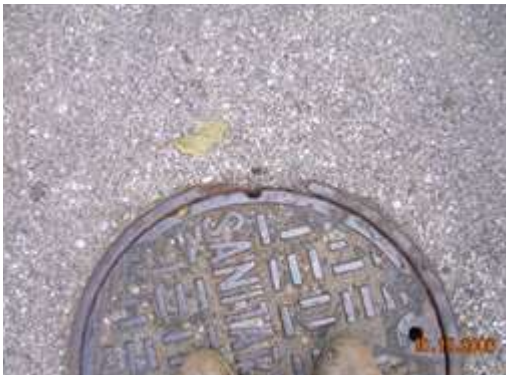
Cracked frame

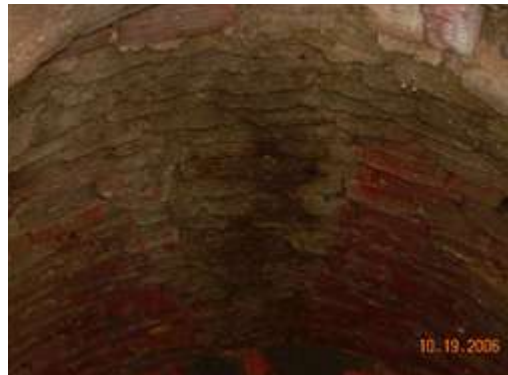
Defect

Frame leaks. Adjustment loose brick, deterioration and infiltration. Corbel deterioration and infiltration - other side.

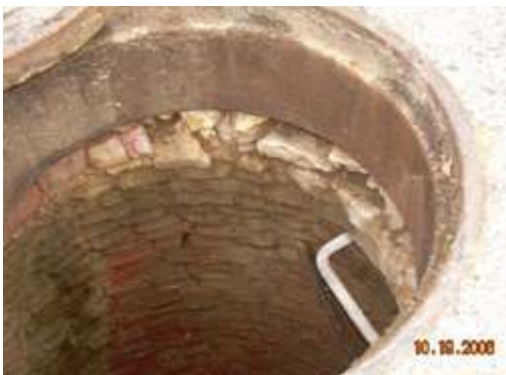
Defect

Frame leaks. Adjustment loose brick, deterioration and infiltration. Corbel deterioration and infiltration.

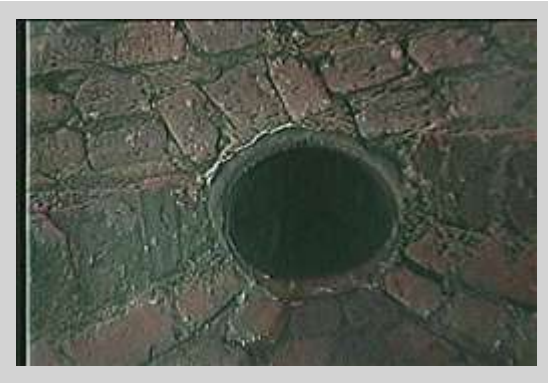
8 in. Circular Gravity Sewer Pipe Out @ 12 O'Clock

Barrel deterioration and infiltration. Channel deterioration.

Infiltration: **Evidence** Pipe Seal Cond: **Unknown**

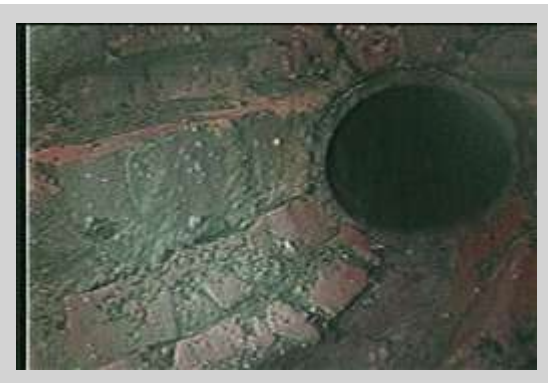
8 in. Circular Gravity Sewer Pipe In @ 3 O'Clock

Infiltration: **Evidence** Pipe Seal Cond: **Cracked**

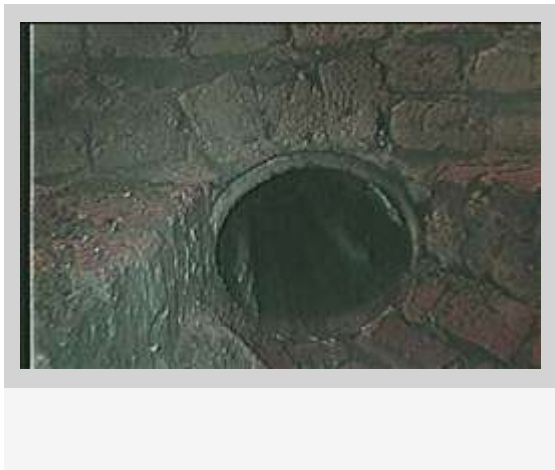
8 in. Circular Gravity Sewer
Pipe In @ 9 O'Clock

Deposits: ☐ None ☐ Mud ☐ Sludge ☐ Debris ☒ **Grease**

Silt Depth: **0** (in.) Deposits Extent: **Light**

Infiltration: **Evidence** Pipe Seal Cond: **Unknown**
